The San Francisco Earthquake and Fire 1906

The
San Francisco Earthquake and Fire

A BRIEF HISTORY OF THE DISASTER

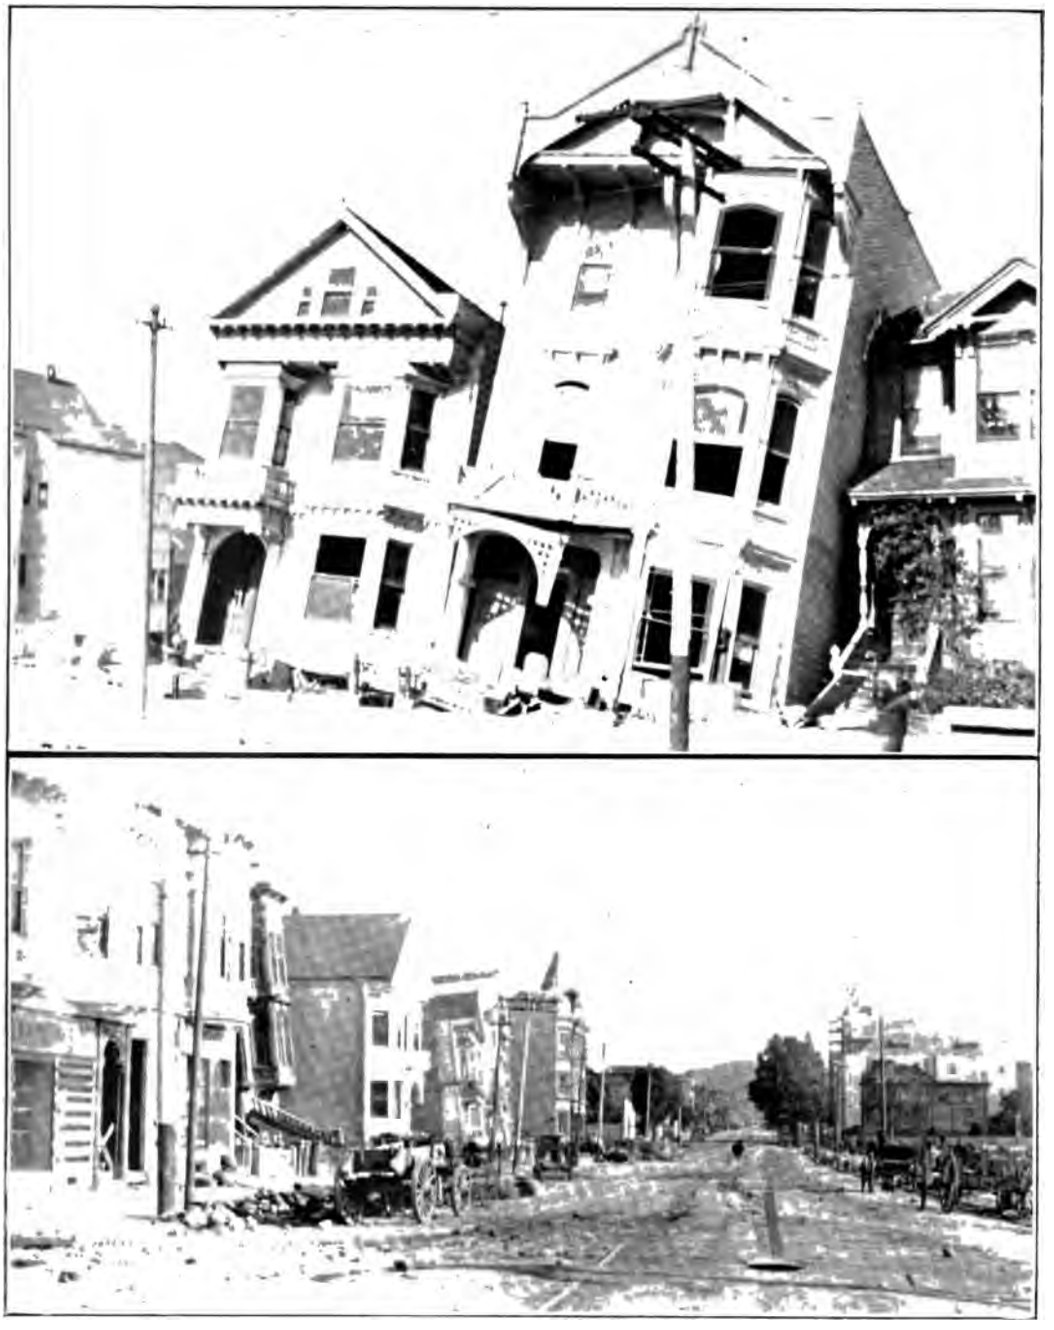
RESIDENCES. Howard Street near Seventeenth Street. The upper view shows two buildings that have been tilted badly out of plumb by the earthquake. The rear portions of the buildings settled about 10 feet. The telegraph poles are approximately plumb. Note the building on the right, the corner of which has broken into the side of the tilted one.

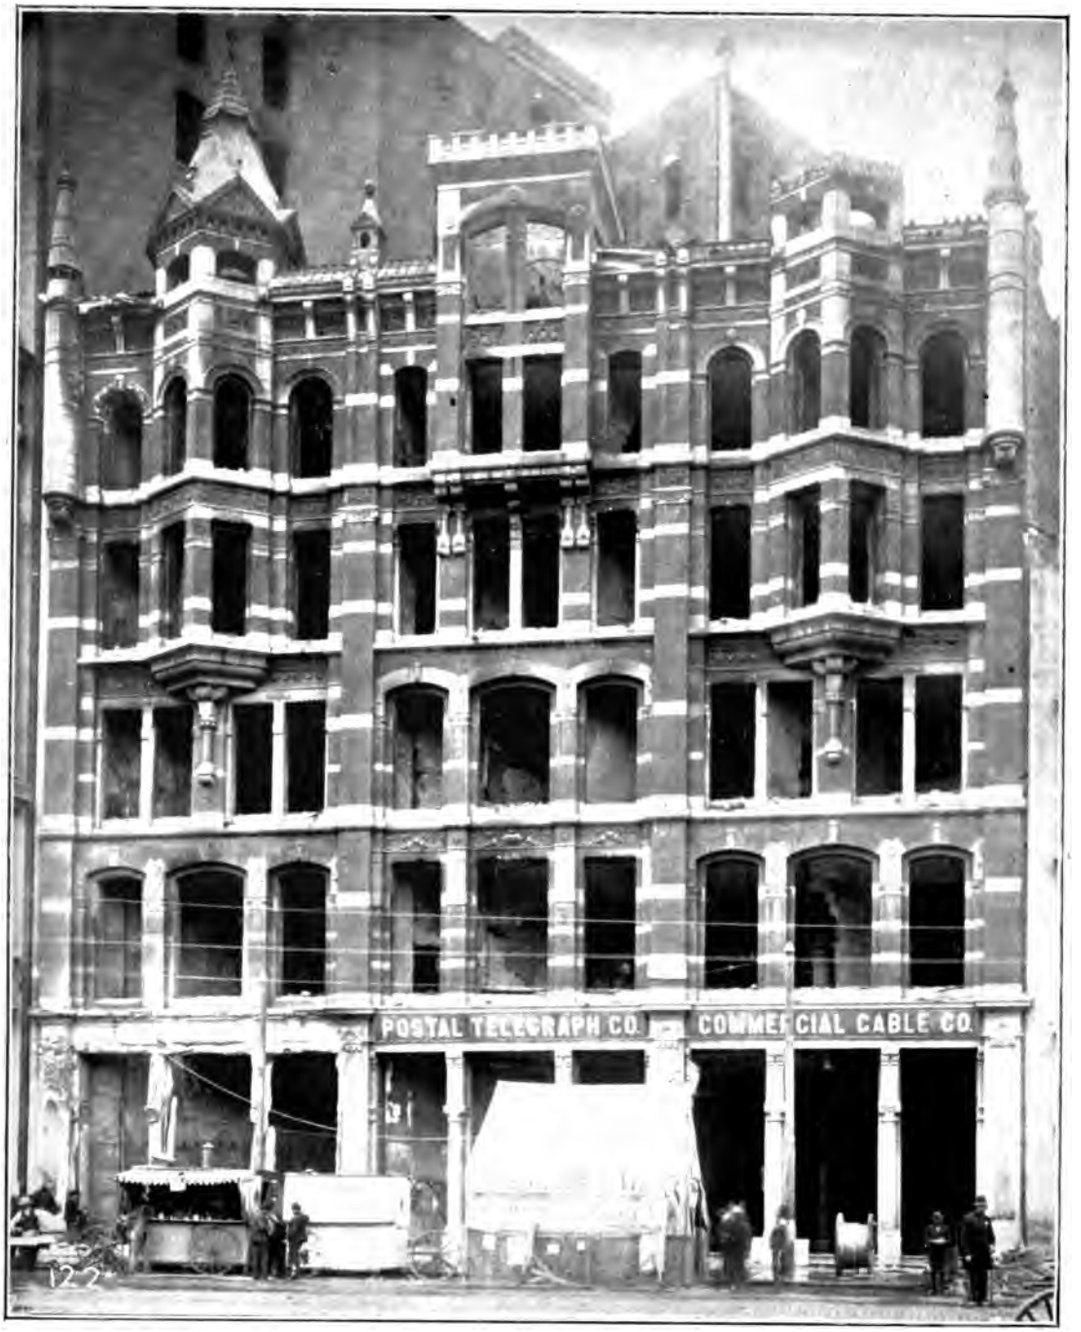
HOBART BUILDING. Market Street, between Montgomery and Sansome Streets. The façade consists of gray granite for the first story and common brick with granite ornamentation above. The granite is badly spalled on the west side at the first-story level, but the front is little damaged elsewhere. The interior is in bad condition, large sections of the flooring having collapsed on account of exposed girders and beams in the basement. The steel framework is badly distorted and warped. The fire-proof floors consist of segmental arches of common brick and brick concrete, with flat wire lath and plaster ceilings underneath. The partitions and column protection are of hollow tile blocks. A large proportion of the partitions are wrecked. The column covering is in fair condition. The flat wire lath and plaster ceilings failed in many places on account of a supporting clip of poor design.

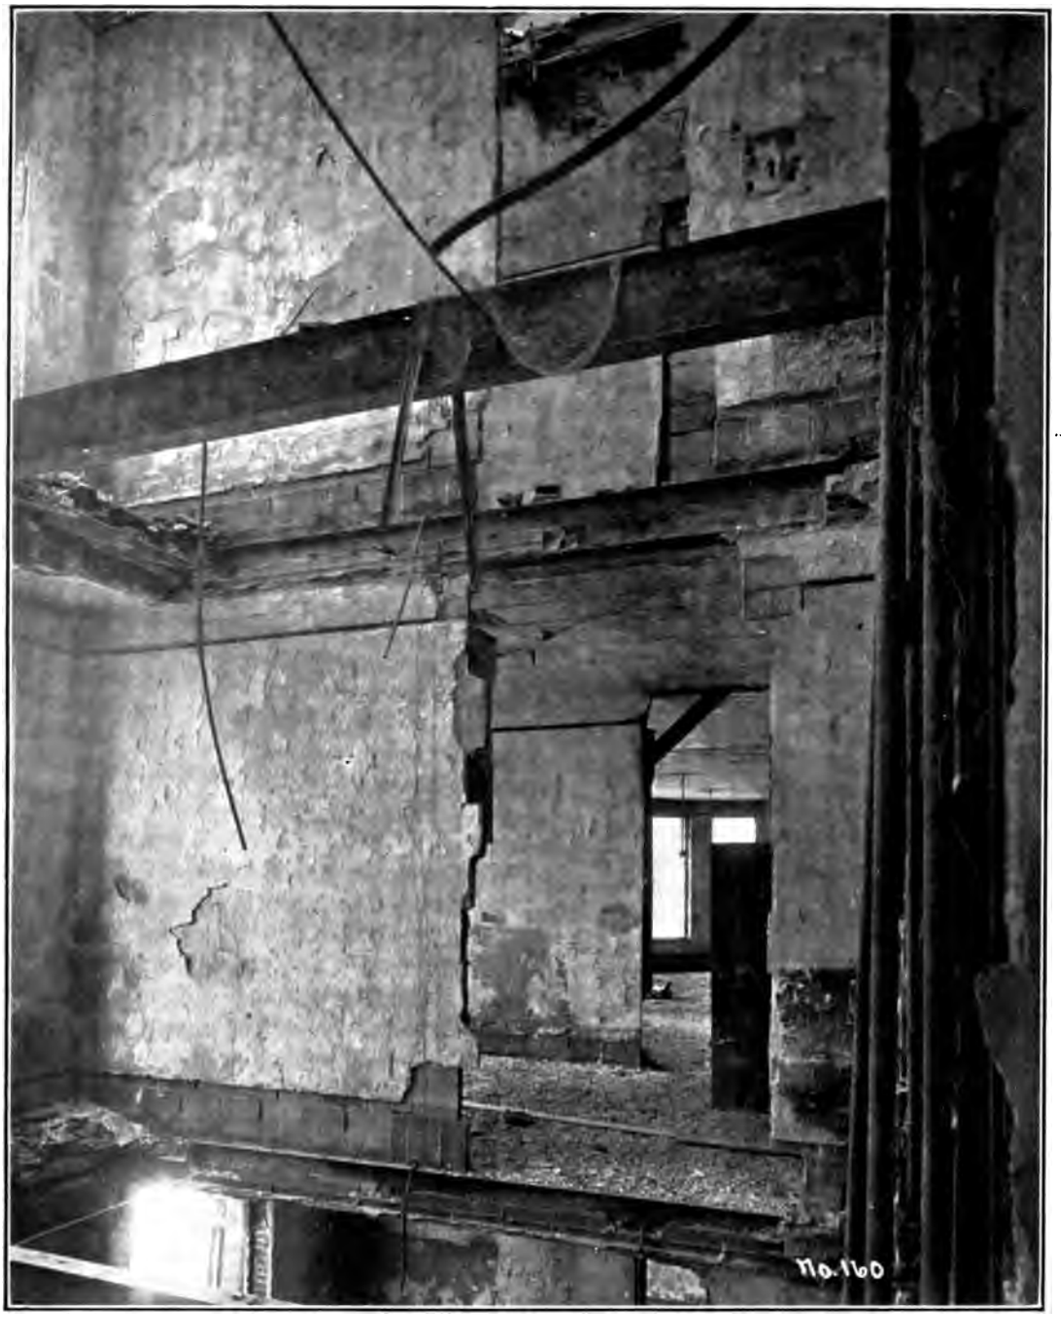
MUTUAL LIFE BUILDING. Fifth Story. Showing the openings through the fifth and sixth floors where the hollow tile arches were broken out by a falling safe. The broken tie rods are still hanging from the beams. The pipes on the right hand side were enclosed within the hollow tile column protection, and no doubt contributed toward its failure.

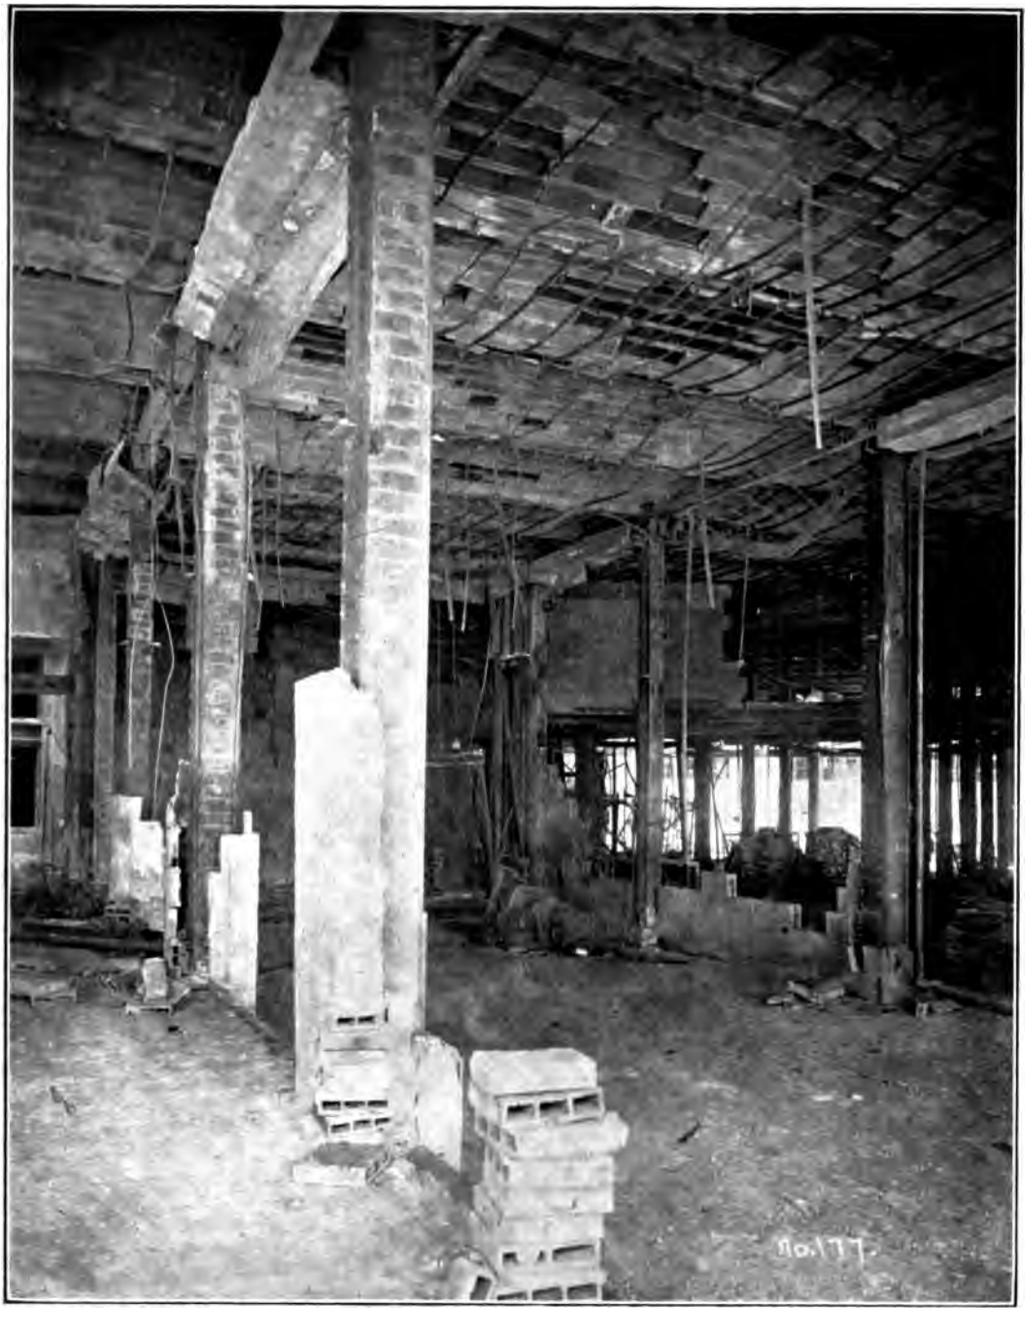
FLOOD BUILDING. First Story. The columns are protected by filling the re-entrant rectangular space with common brick, and then enclosing them with 3" hollow tile blocks. The Roebling wire lath was laced to the ceiling furring with No. 16 B. & S. copper wire. The low fusing point of copper wire caused it to weaken, and allowed the lath and plaster to fall away from the supports, exposing the under side of the segmental hollow tile arches to the flames, which seriously damaged them as shown. In other portions of the building where the wire lath and plaster ceilings remain in place, the floor arches above are uninjured. The great height of this story was the cause of more damage to the partition blocks than in the other stories, which were of lesser height. The

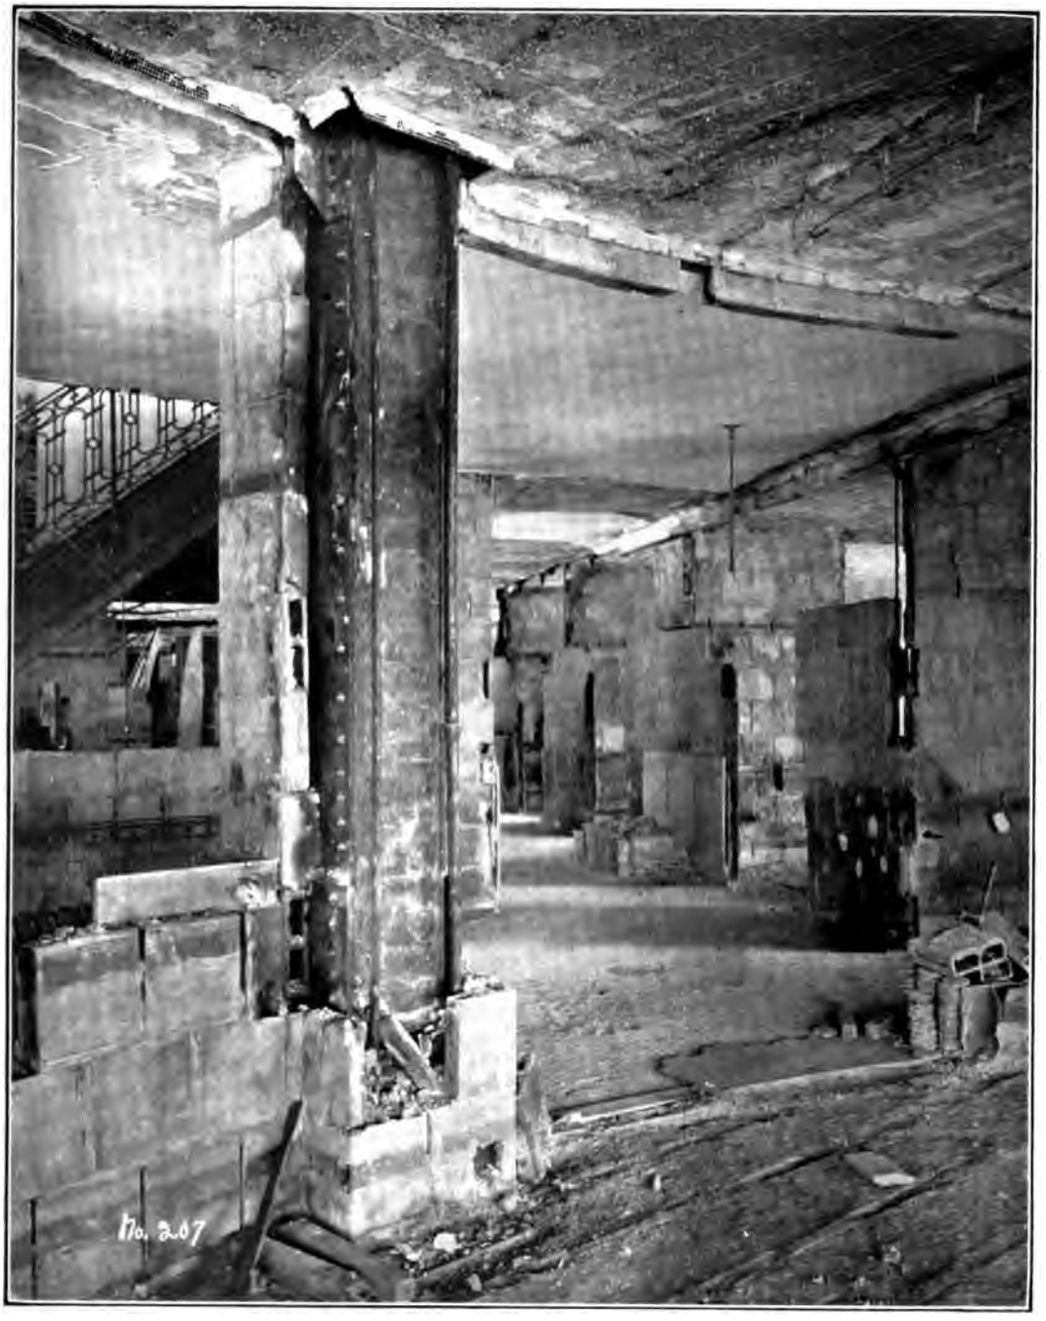
FLOOD BUILDING. Fourth Story, southwest corner. Showing typical damage to the 4" hollow tile partitions that were built solidly from the top of the fire-proof flooring through the Roebling wire lath ceiling to the under side of the hollow tile arches above. Under these conditions, when the partitions expand from heating, there is a tendency to buckle or deflect, which frequently causes failure. The blocks over the door openings have generally been forced down into the opening, and have dropped out from this cause. Some of the partitions that remain standing are weak and in a tottering condition. This illustration shows also the brick-filled column inclosed by 3" hollow tile blocks. This is an improvement over the ordinary method, but could be rendered still more efficient by filling the space between the hollow tile protection and the steel member solidly with cement mortar, and by providing a separate enclosure for pipes.

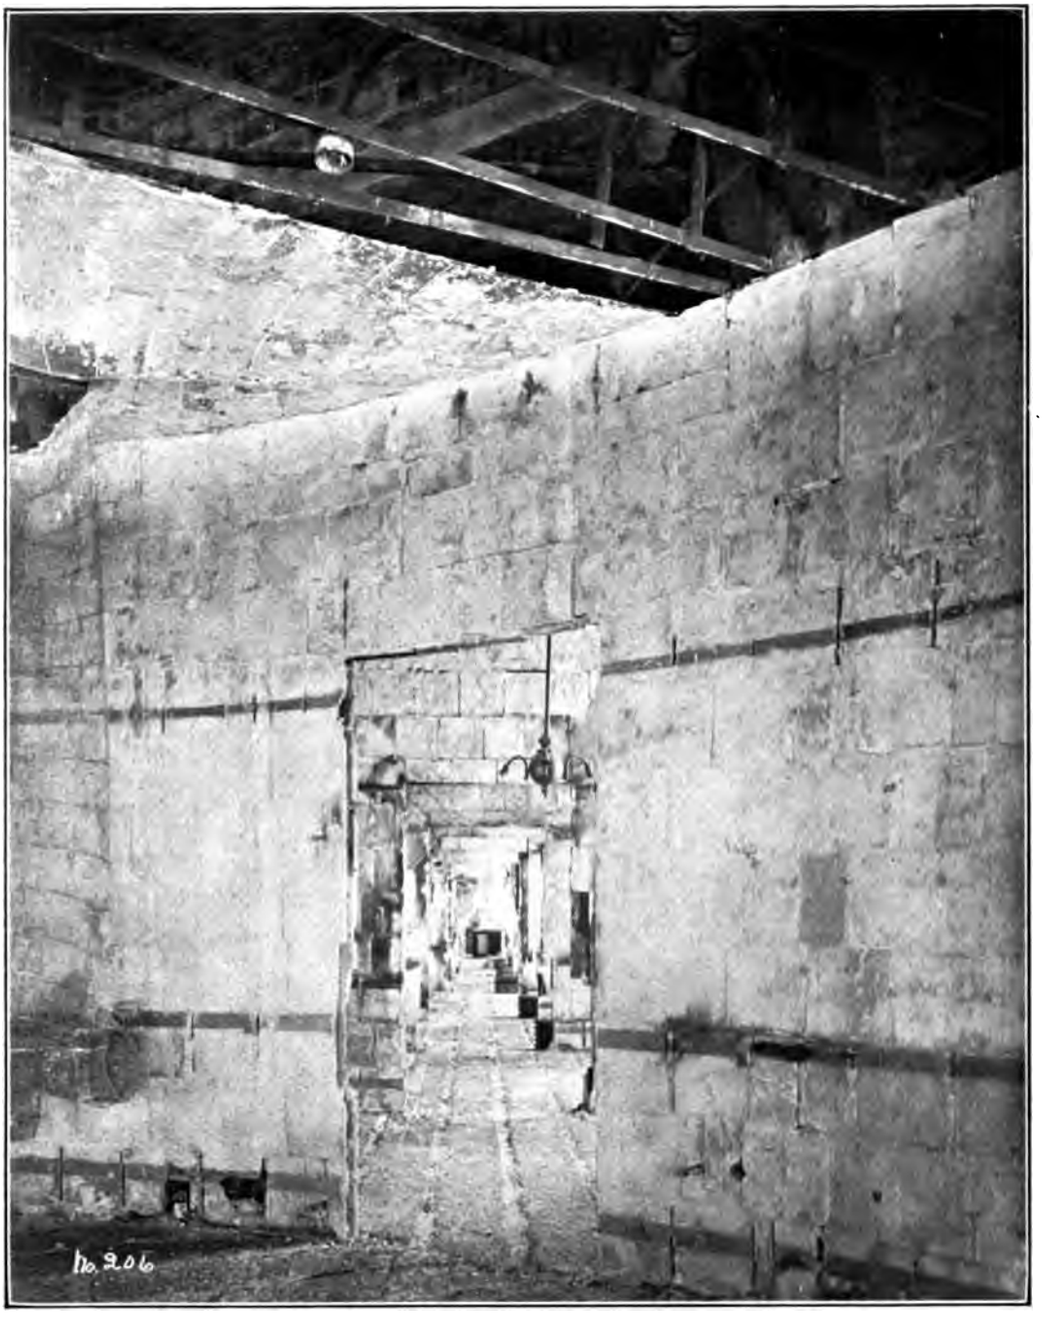
FLOOD BUILDING. Tenth Story. Showing the typical condition of the 4" hollow tile partitions that were built from the top of the fire-proof flooring to the under side of the Roebling wire lath suspended ceiling. The partitions in this story were in much better condition than in the lower stories because the wire lath ceiling acted as a cushion and permitted them to expand when heated. The blocks over the door openings remain in place. This view is taken looking through a row of offices. The loose sheets of wire lath shown in the view have dropped away from the supports, on account of being laced to them with copper wire, which is much weaker for this purpose than steel wire.

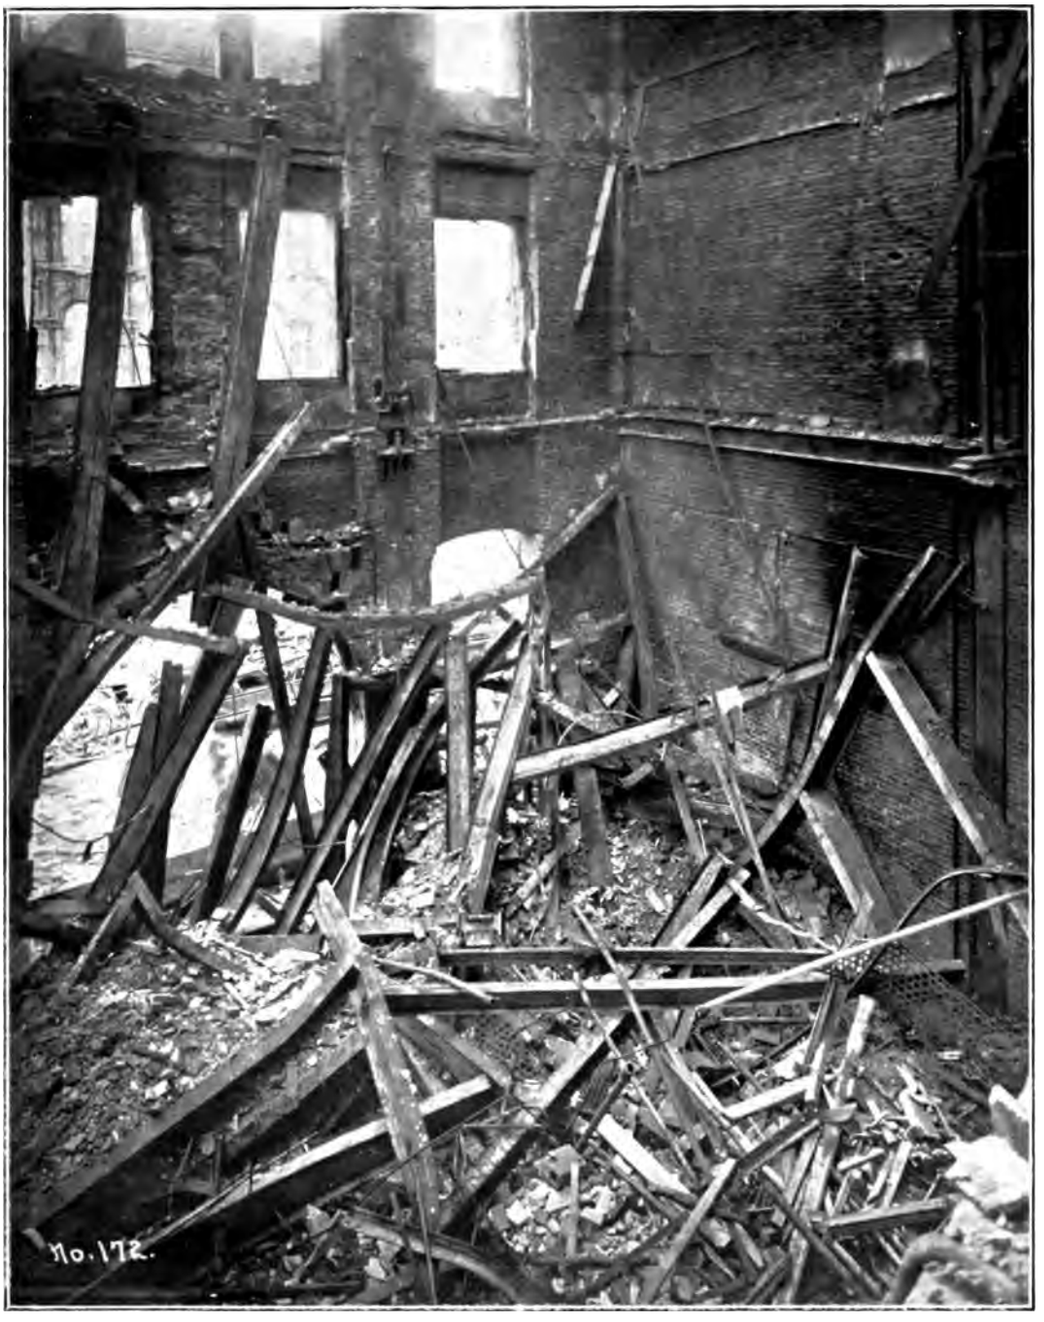
CHRONICLE BUILDING. Showing the interior on the Kearny Street side, which collapsed from the roof, the wreckage filling the basement to the ground-floor level. The columns are of cast iron, with steel framing supporting the floors. Two double beams supporting bay window projections on the left-hand side have broken off at the separator holes and remain hanging in a

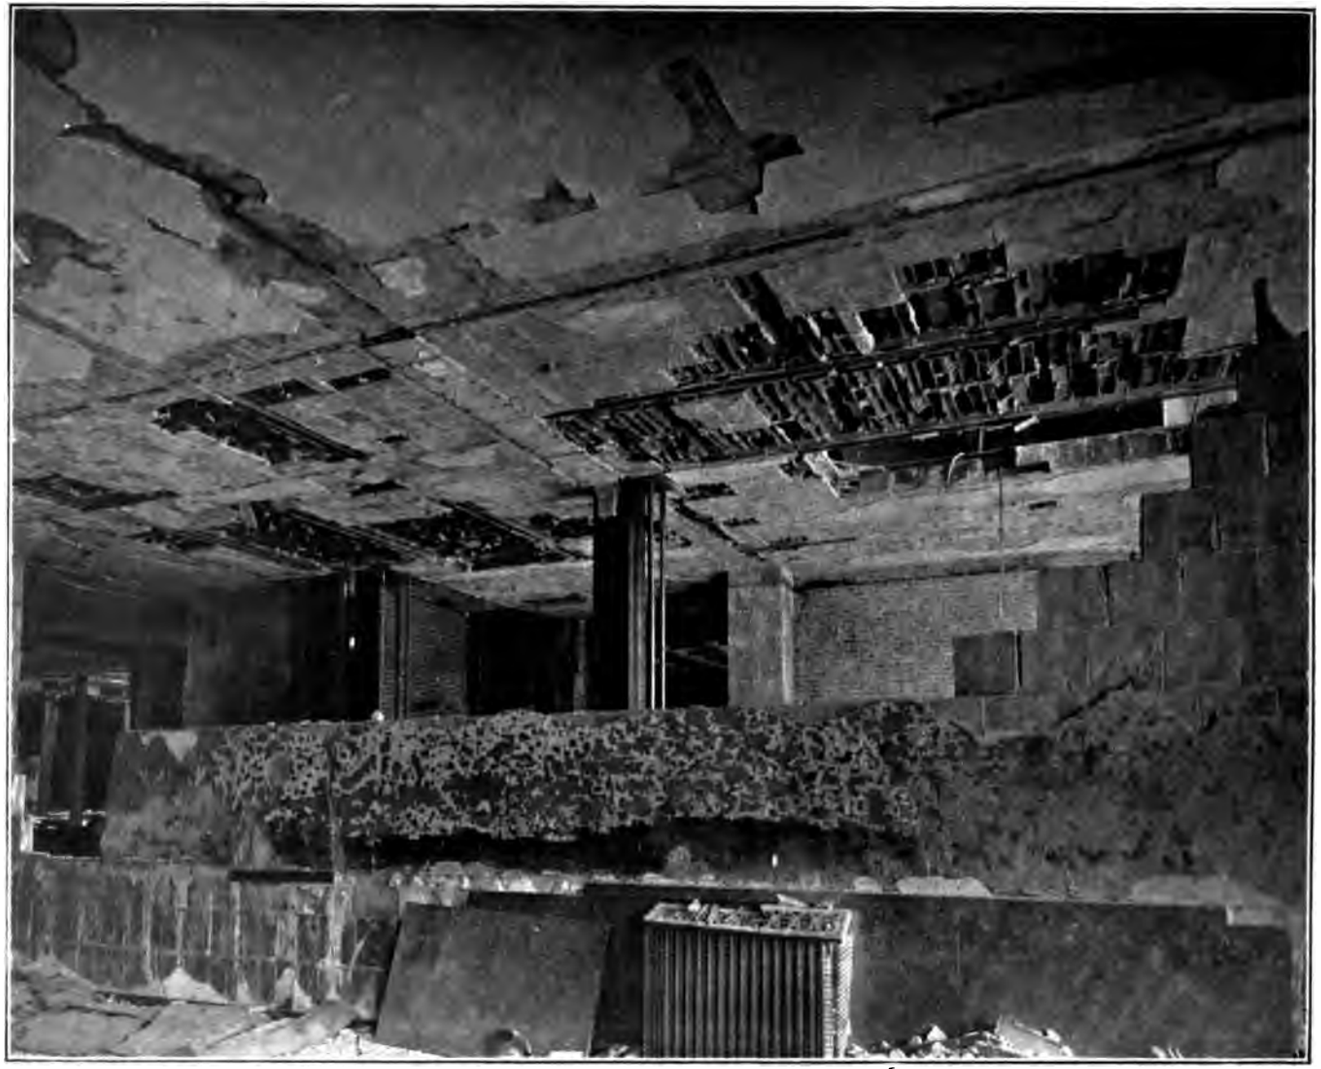
MILLS BUILDING. First Story. Showing the failure of the hollow tile column protection, and the damage to the hollow tile floors. A large proportion of the partition blocks in this building are down.

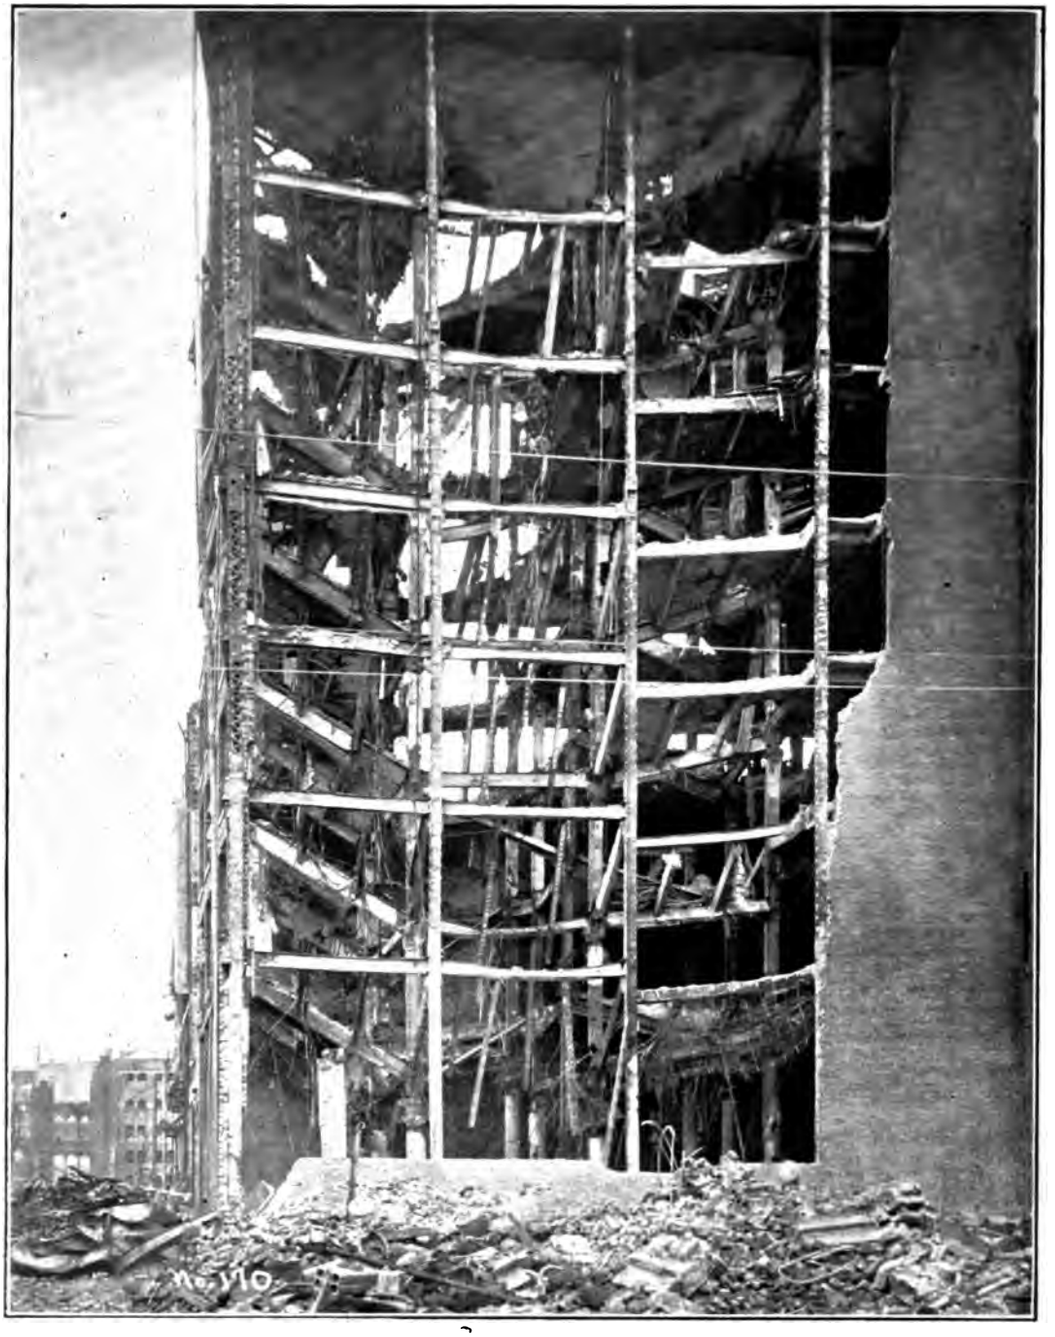
KAMM BUILDING. Showing the collapsed rear portion of the building caused by column failures in the basement. The tenacity of the connections of the wall girders at the columns is remarkable. Two beams framed to them, when carried downward in the centre, have twisted the girders in the middle section through an angle of about 80 degrees from the vertical. The Roebling concrete floors cling to the beams; seven tiers in the rear of the building being inclined at an angle of about 35 degrees, and other sections of the floors being warped and distorted into almost every conceivable shape. Note the curved skyline of the rear where the central columns have been drawn inward by the collapse.

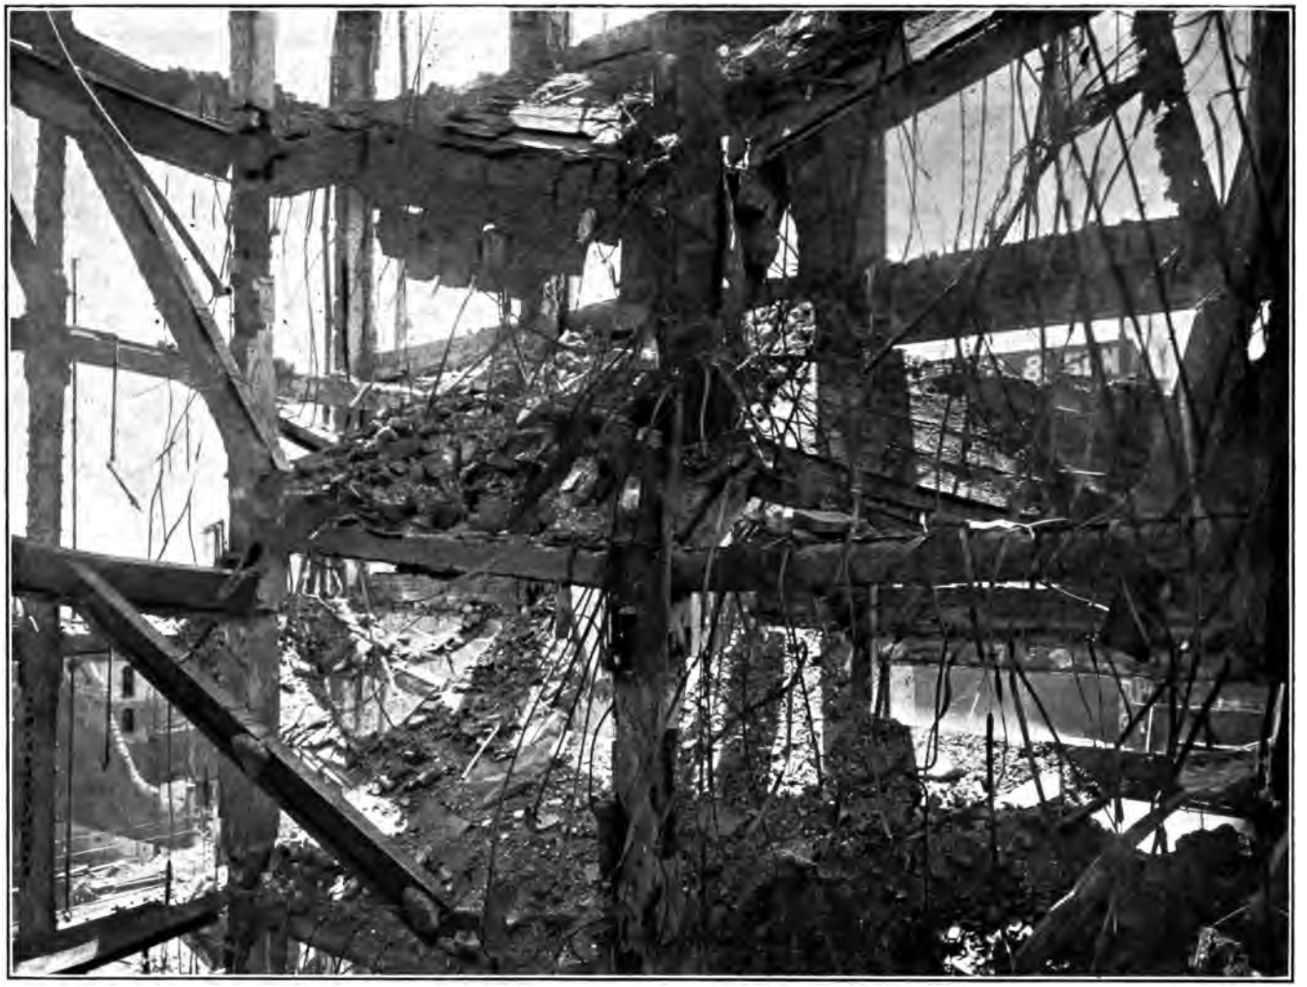
KAMM BUILDING. Fifth Story. From within, looking into the rear portion of the building, which was wrecked by column failures in the basement. The Roebling concrete floor slabs of seven tiers at the rear end of the building are inclined at an angle of about 35 degrees, and remain generally in place. This view was taken to show a badly buckled latticed channel column in the centre foreground which was caused by abnormal strains and loads, and not by heat. Note the tenacity of the crimped wire lath and cement plaster soffit protection, which remains in place after the wreckage has destroyed the floor slabs.

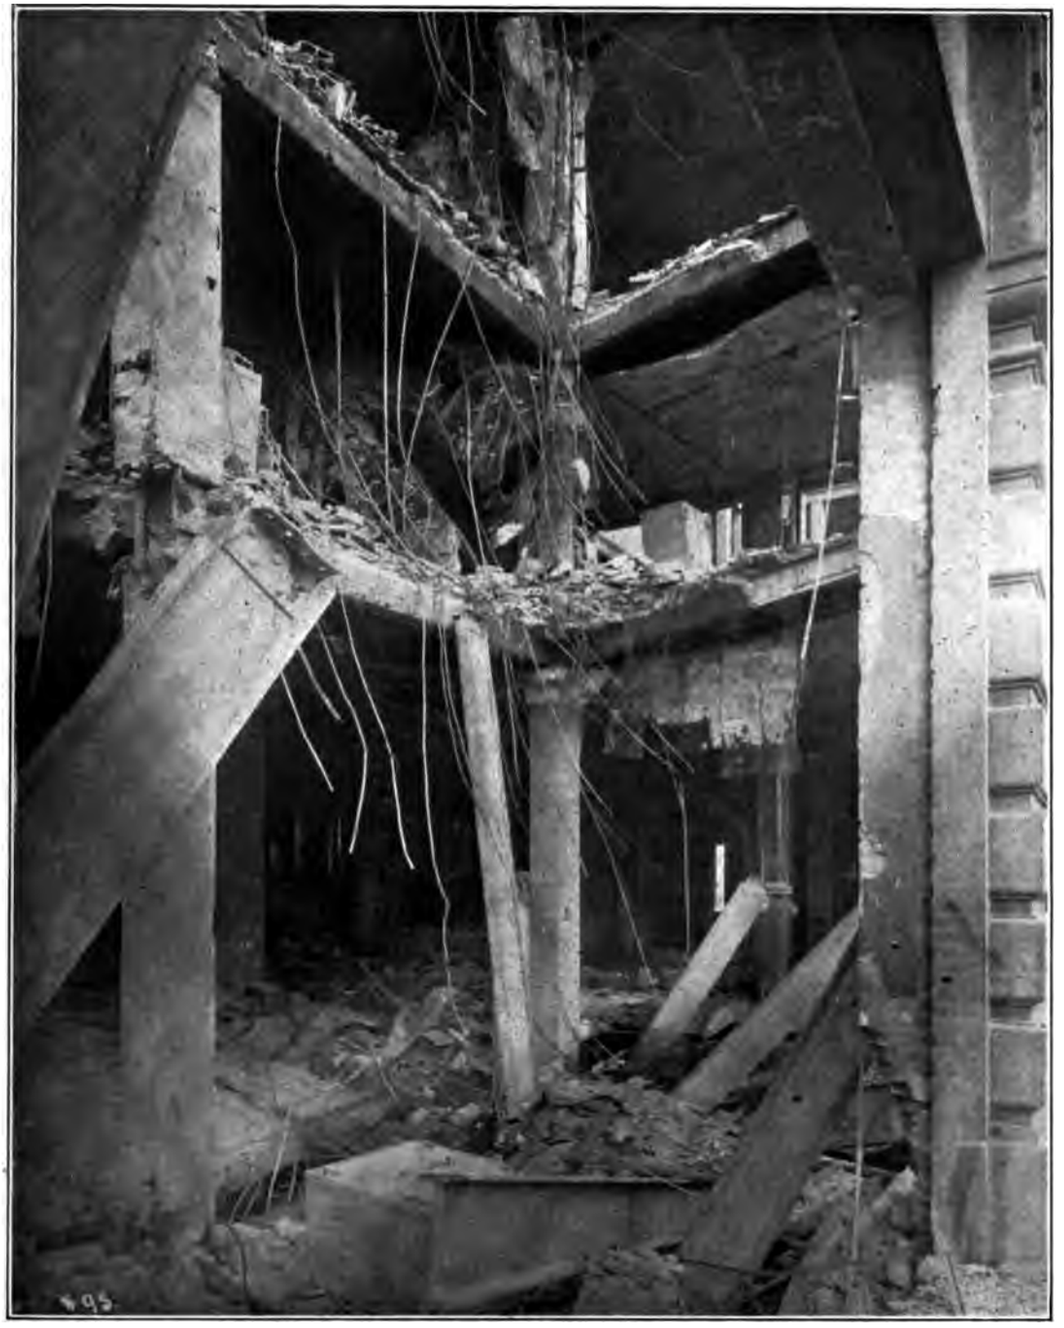
RIALTO BUILDING. First Story. Looking from the building line near the New Montgomery Street entrance. Showing a collapsed section caused by the buckling of a column in the basement story.

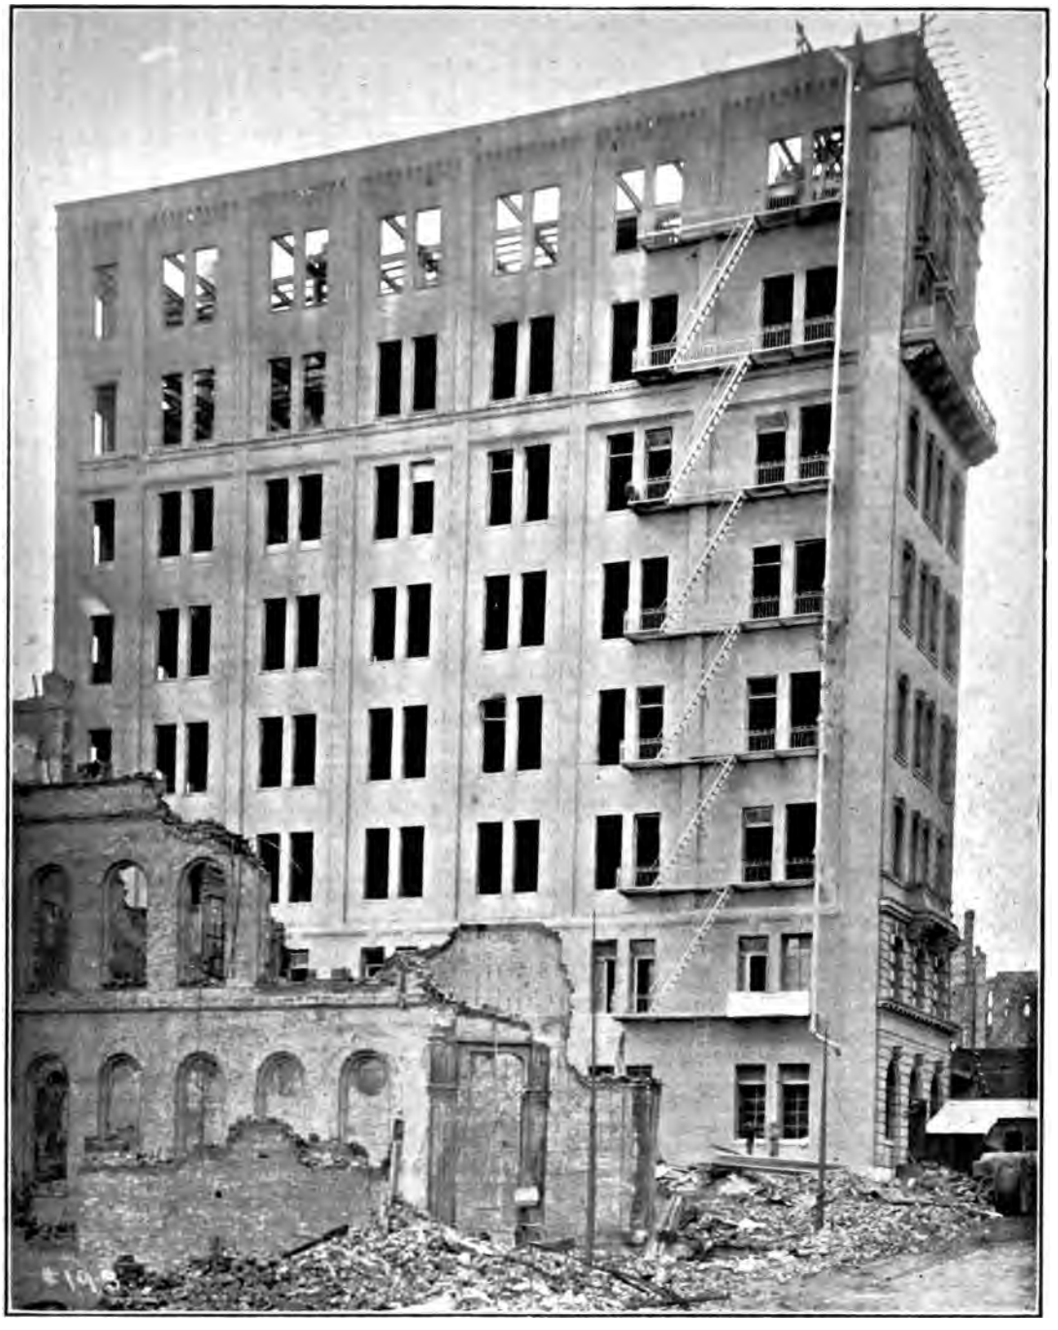
PACIFIC STATES TEL. & TEL. CO.'S Main Office, South Side of Bush Street, between Grant Avenue and Kearny Street. The façade of buff terra cotta pressed brick and terra cotta ornamentation is in good condition, there being only a few slight earthquake cracks at the fifth and sixth story levels. All the window openings of this building were protected by metal and metal-covered inside shutters. The fire entered through the only unprotected door opening in the rear at the first-story level, consuming everything that was combustible within, and rendering the fire-proof barriers that had been provided useless, except to prevent draughts. This building was filled with supplies and equipment, producing an intensely hot fire. The Roebling concrete floors and column protection are uninjured. The Roebling wire lath and plaster ceilings and wall furring are in good condition throughout. The wire lath and plaster partitions have buckled out of plumb in some cases. In the roof tier, reinforced concrete beams were employed between the girders. The fire caused the total failure of one of these, and deflected the rest in this tier so that they required renewal. The photograph was taken after the repairs of the roof tier had been started. The steel work throughout is uninjured.

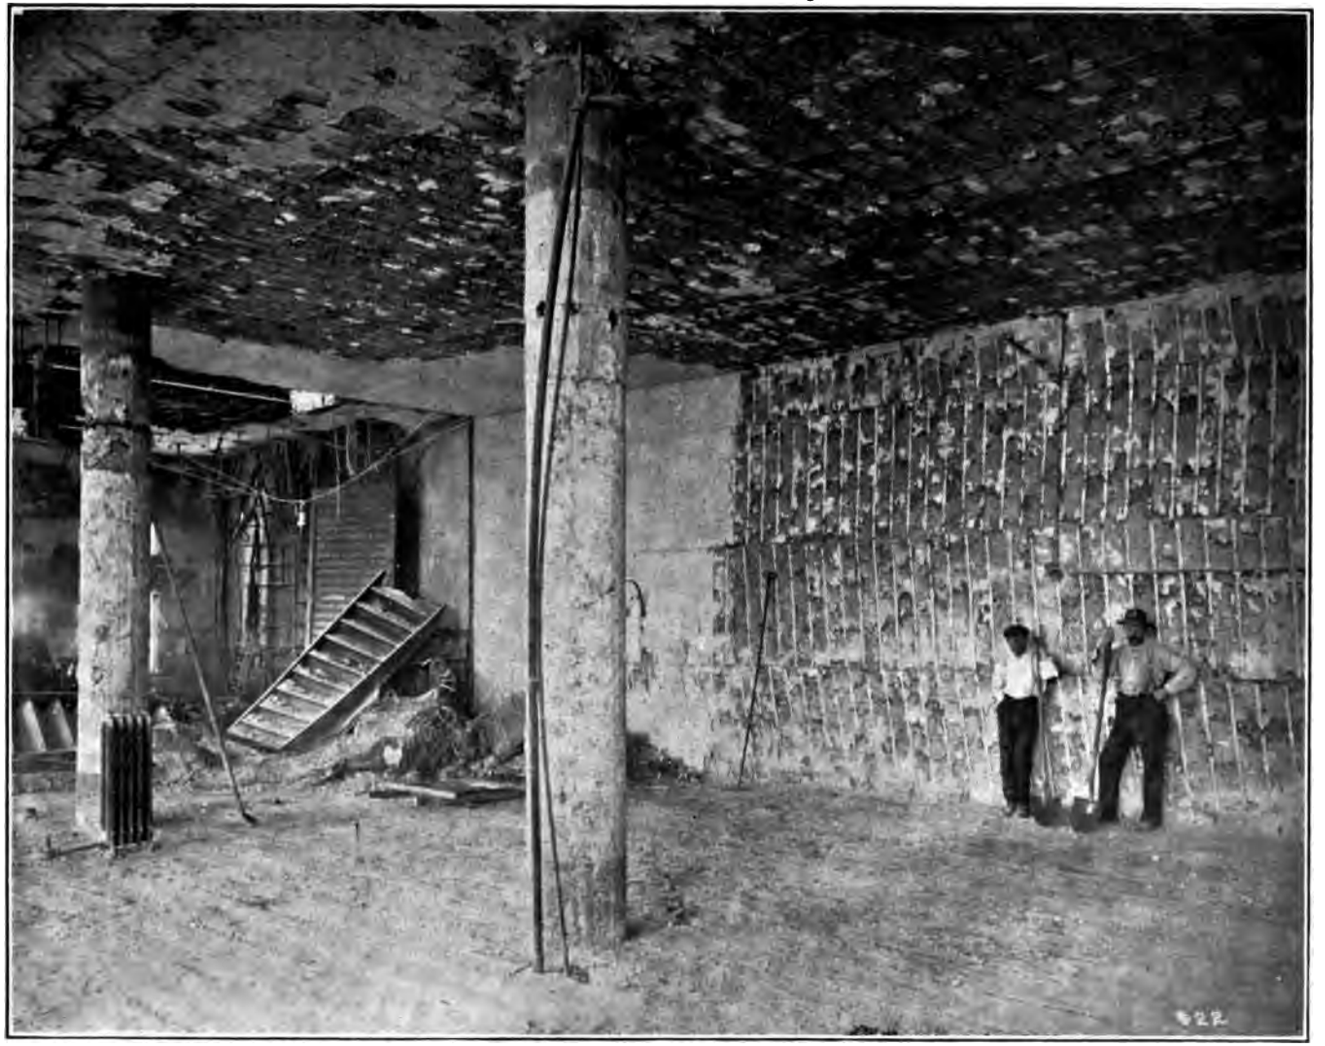
PACIFIC STATES TEL. & TEL. CO.'S Main Office. Fourth Story. Showing the typical condition of the Roebling concrete floors, wire lath and plastered ceilings, wire wall furring and concrete column protection. The photograph was taken after the repair work had started and some of the plaster had been removed. This story was subjected to a severe fire, particularly around the cable rack well in the rear corner. The intense fire at this point spalled the brick wall and caused the failure of the cast-iron and metal tread stairway.

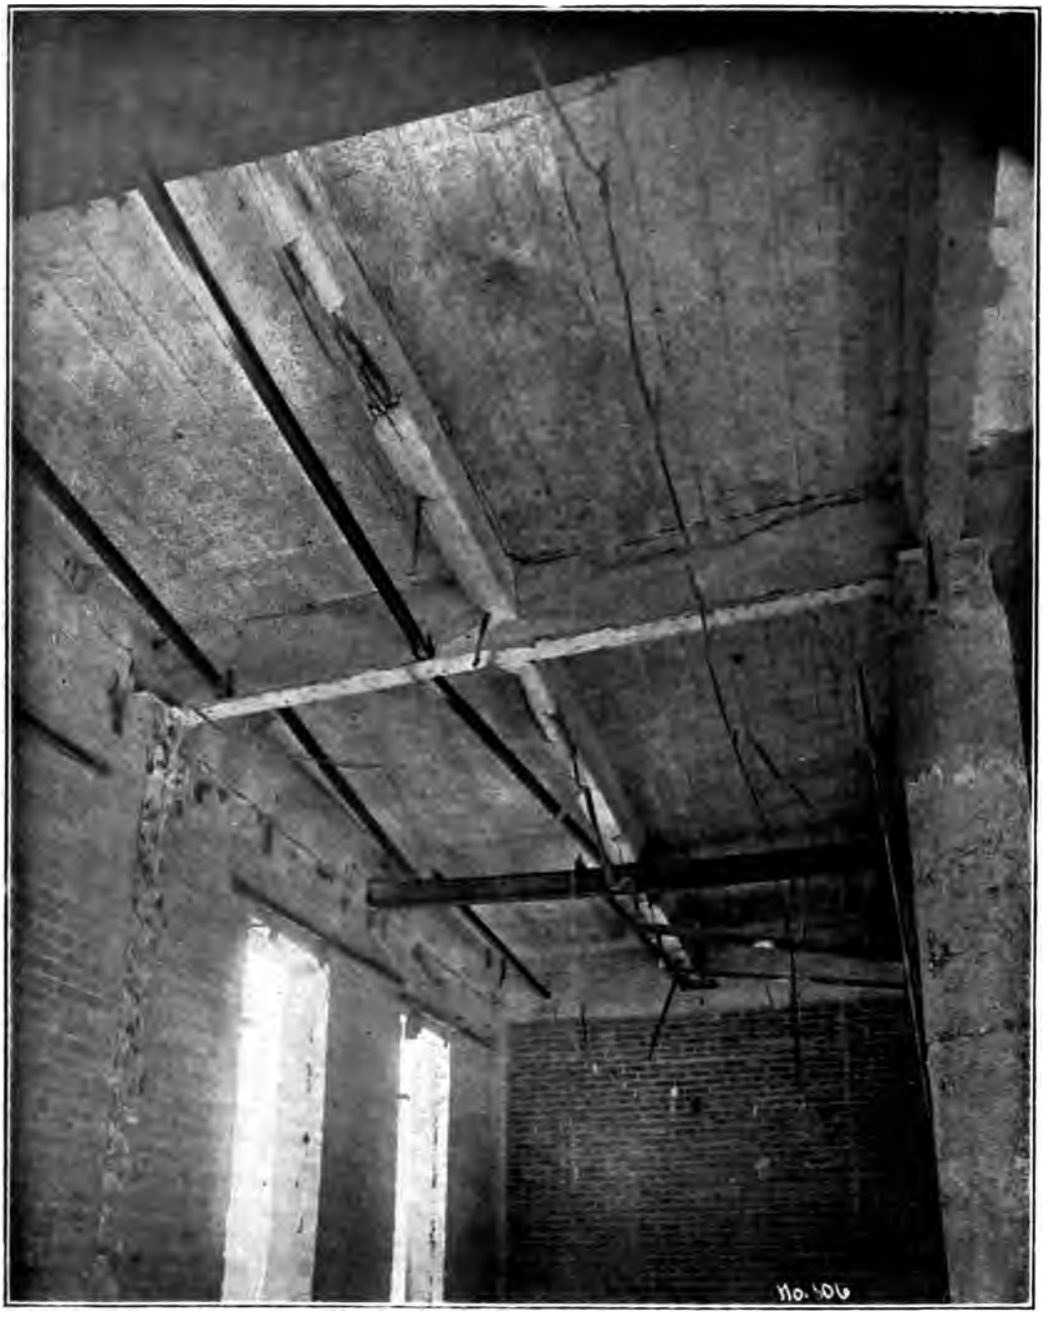
PACIFIC STATES TEL. & TEL. CO.'S Main Office. Showing the partial failure of the reinforced concrete beams supporting the roof, which were damaged by fire. The photograph was taken after the temporary shoring had been put in place.
